Repairing the Marconi TF2002B Signal Generator Joe Bell G4PMY

This piece of equipment has sat in the Hack Green Bunker museum for 5 years and I often wondered if it worked. I decided to test it which was a mistake as once you know something is not working, then you are compelled to find out why.

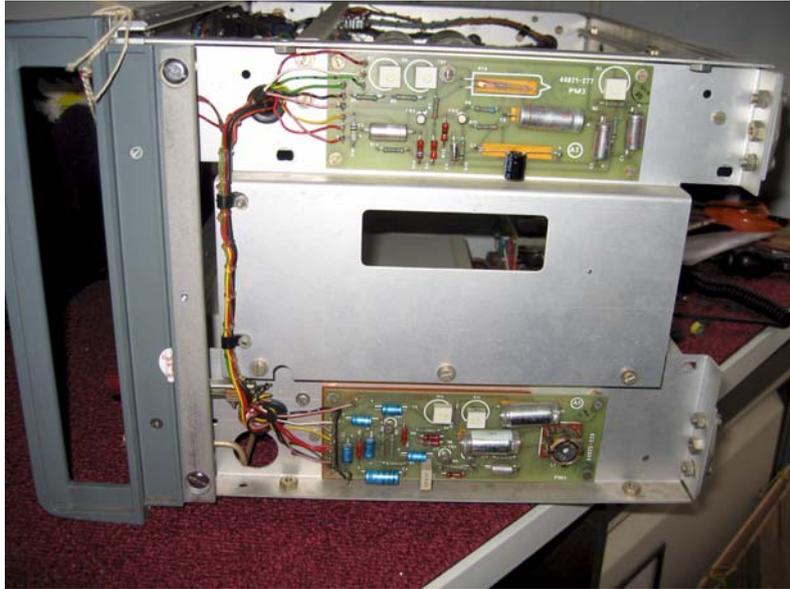
Now what to do next. I decided to tackle the audio oscillator which is in fact a Wien Bridge circuit with switched capacitors for differing frequency ranges. The oscillator board is mounted on the side of the case and a scope revealed that no oscillation was taking place.

A quick voltage check found no bias on some of the transistors and this was tracked down to a short circuit electrolytic capacitor. The new (black) replacement capacitor can be seen in the following photograph. This repair produced audio oscillation and indication on the modulation meter.

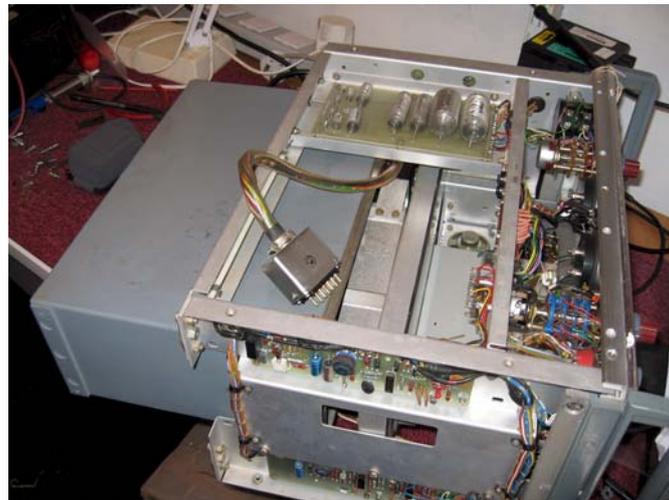
There was still no RF output and no RF indication on the Carrier meter. This left no alternative but to remove the RF unit for examination and repair. The design of the unit makes this a simple task. Removing four screws in the side of the unit allows the whole unit including scale and knobs to be drawn out through the back of the instrument. The module plugs into the carcase via a multi-way plug and socket. Here you can see the RF unit half way out.

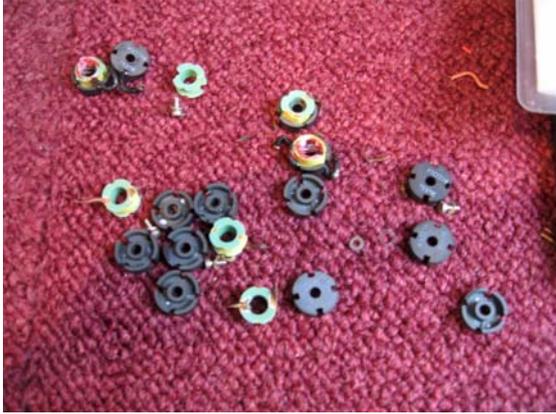
Once removed and the cover slid off the RF unit, it became apparent that the circuit I had did match some of the filter boards. All of the voltages and control lines into the RF unit go through two filter sections. The filters are wound on plastic formers and housed in ferrite pots. I found no less than 12 of these filters to be open circuit.

I removed the first one for examination and it read 20K ohms whilst on the board, but promptly fell to bits on removal. Heat being the main cause as both wire and former being brittle. Fortunately the filters are all stock values and were replaced with modern off the shelf units. I found that all 12 filters which were discovered to be OC were brittle and I eventually decided to replace all of the filters including those which measure OK.

The filters which were removed after being tested with an ohm-meter. Most read High Ks of resistance and should have been in the low 10s of ohms.

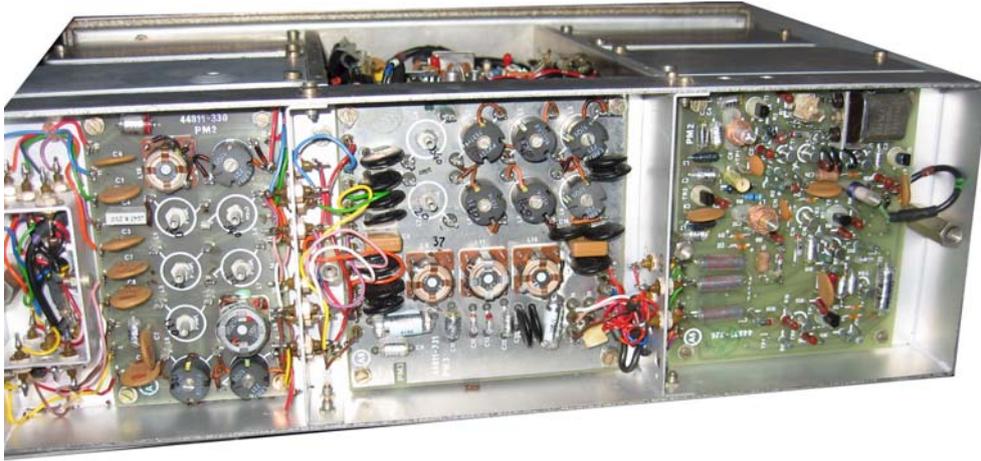
Here is a view of the two filter sections, extreme left and centre. To the right is the calibrator oscillator. In this picture you can see where I have removed 8 of the cores. To fit the new components I lifted the PCB and removed the metal studs which can be seen in the photo. This provided the extra space needed to fit the new inductors which were soldered to the original tags.

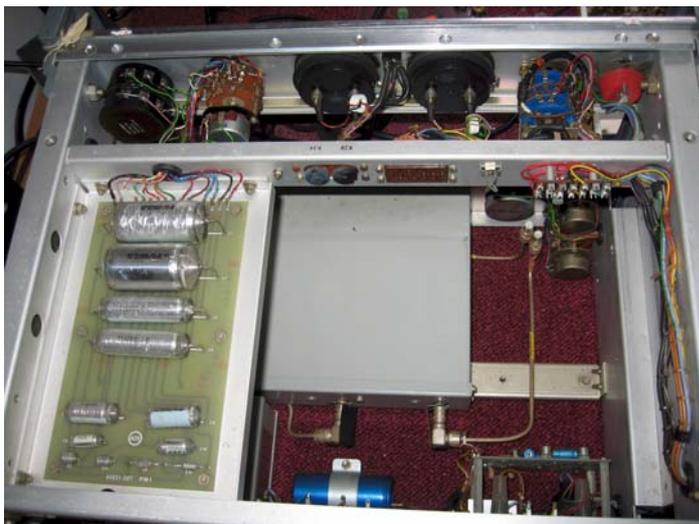
In this photo can be seen bottom left the suflex capacitors which are switched into the Wien oscillator to produce the audio for modulation.

The grey box at the centre of the photo is the switched RF attenuator.

Bottom right is the mains power inlet and the 15v regulator.

To the right can be seen the internal loud-speaker which can only be changed when the RF unit is out of the case. The grey box with the silver label is the mains power transformer.

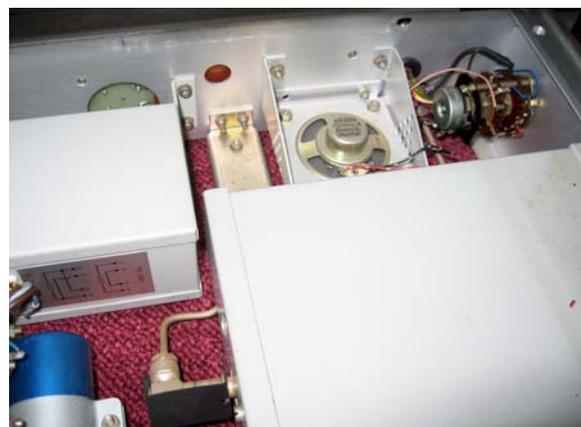
Finally the RF output level was checked. With the RF attenuator switched to zero, the output level should be 1v into 50 ohms. This is normally done with an RF voltmeter, but I used a spectrum analyser. The 1v output should coincide with the Carrier level meter red calibration mark. All OK.

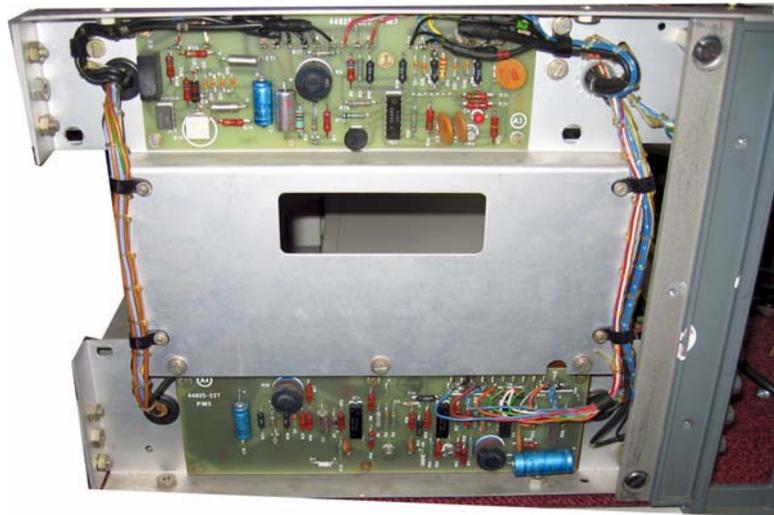
The final photographs are the PCB board A3 & A4 Modulation drive and monitor (A3) and RF oscillator supply stabilizer (A4).
